- High amounts of deflection cause users to feel unsafe even when bridge is structurally sound
- Apply OMA concepts
- Compare results with a SAP2000 Model generated during CEE 744

# Campus Dr. Pederstrian Overpass P-13-769

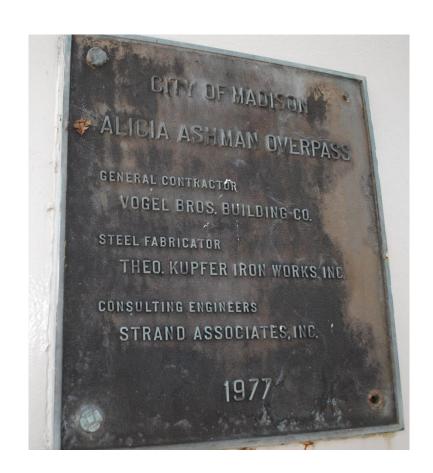
- Named after:
  - Alderman Alicia Ashman
- Built in 1977
- Materials:
  - Concrete
  - Steel
- Bridge Geometry:
  - Arch Span: 180 x 10 ft
  - Ramp: 200 ft

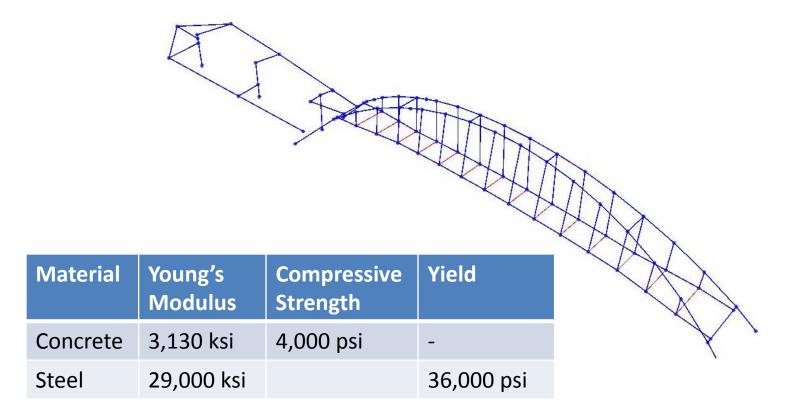
#### SAP2000 Model Given

- •Frame elements used to model hangers, arch, beams and columns
- •Shell elements to represent concrete slab

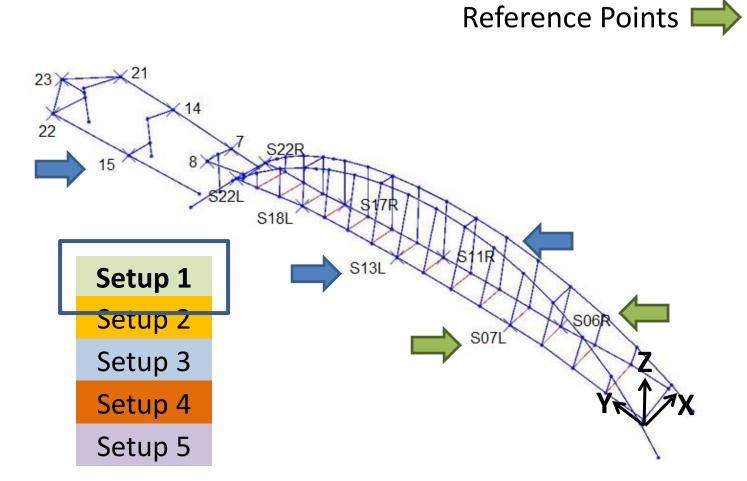
#### Measurement Set Up

- Five X-Y-Z accelerometers were used to collect data
- Only X and Z directions were recorded

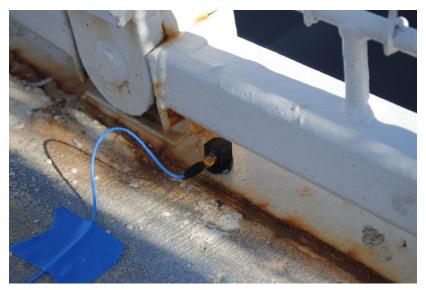
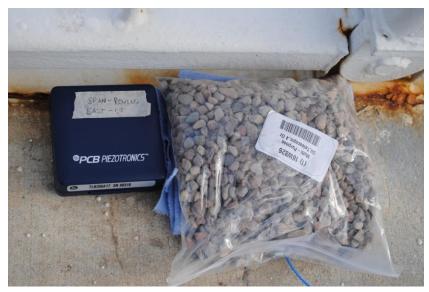
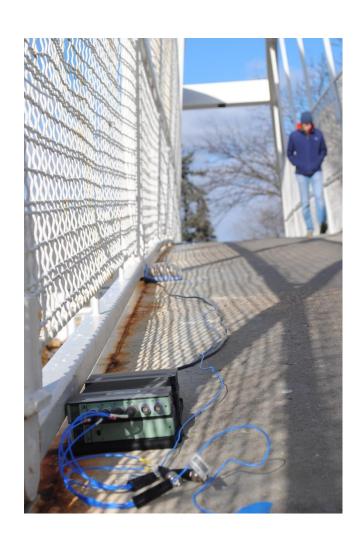
## Measurement Day

- Randomly excite bridge by walking and jumping on structure
- Used 30 averages per set up to determine dynamic response up to 25 Hz

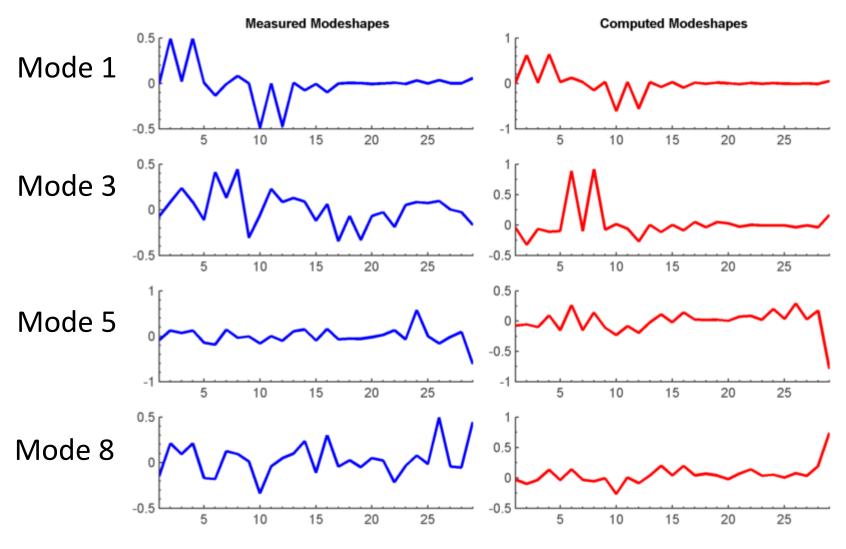
### Most Comparable Modeshapes

Mode	Measured	Computed		
	Frequency [Hz]		<b>Variation %</b>	
1	1.91	2.05	7.62	
3	3.45	3.87	12.33	
5	4.44	4.50	1.30	
8	5.58	5.50	1.40

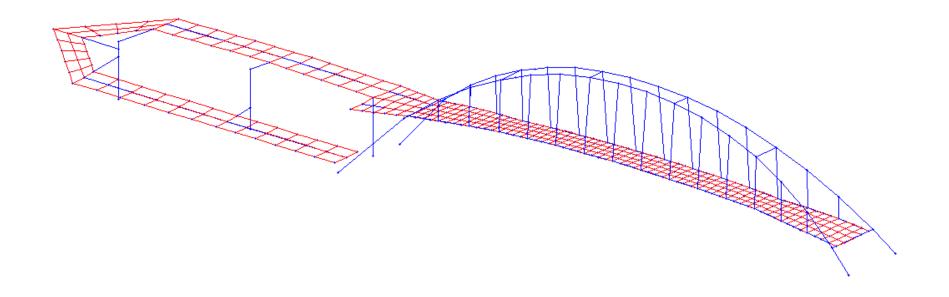
#### SAP2000 Modification 2

- Section areas were checked
- Slab thickness increased 2 inches
- Material properties changed to standard SAP2000 4000 psi concrete and A36 Steel  $(\sigma_{yield} = 36 \text{ ksi})$
- Ramp slab added
- Bridge slab refined
- Previous modification kept

Mode	Frequency Original Model	Frequency Modification 1	% Change compared to original	Frequency Modification 2	% Change compared to original
_	Cyc/sec	Cyc/sec	<i>•</i>	Cyc/sec	
1	2.0534	2.035	1%	1.8221	11.3%
2	2.2947	2.0725	10%	1.8751	18.3%
3	2.3445	2.2054	6%	2.1849	6.8%
4	2.8391	2.4196	15%	2.8286	0.4%
